WATCHUNG LAKE DAM

NJ 00767

PHASE 1 INSPECTION REPORT
NATIONAL DAM SAFETY PROGRAM
DAEW61-79-C-0011

JULY 1981

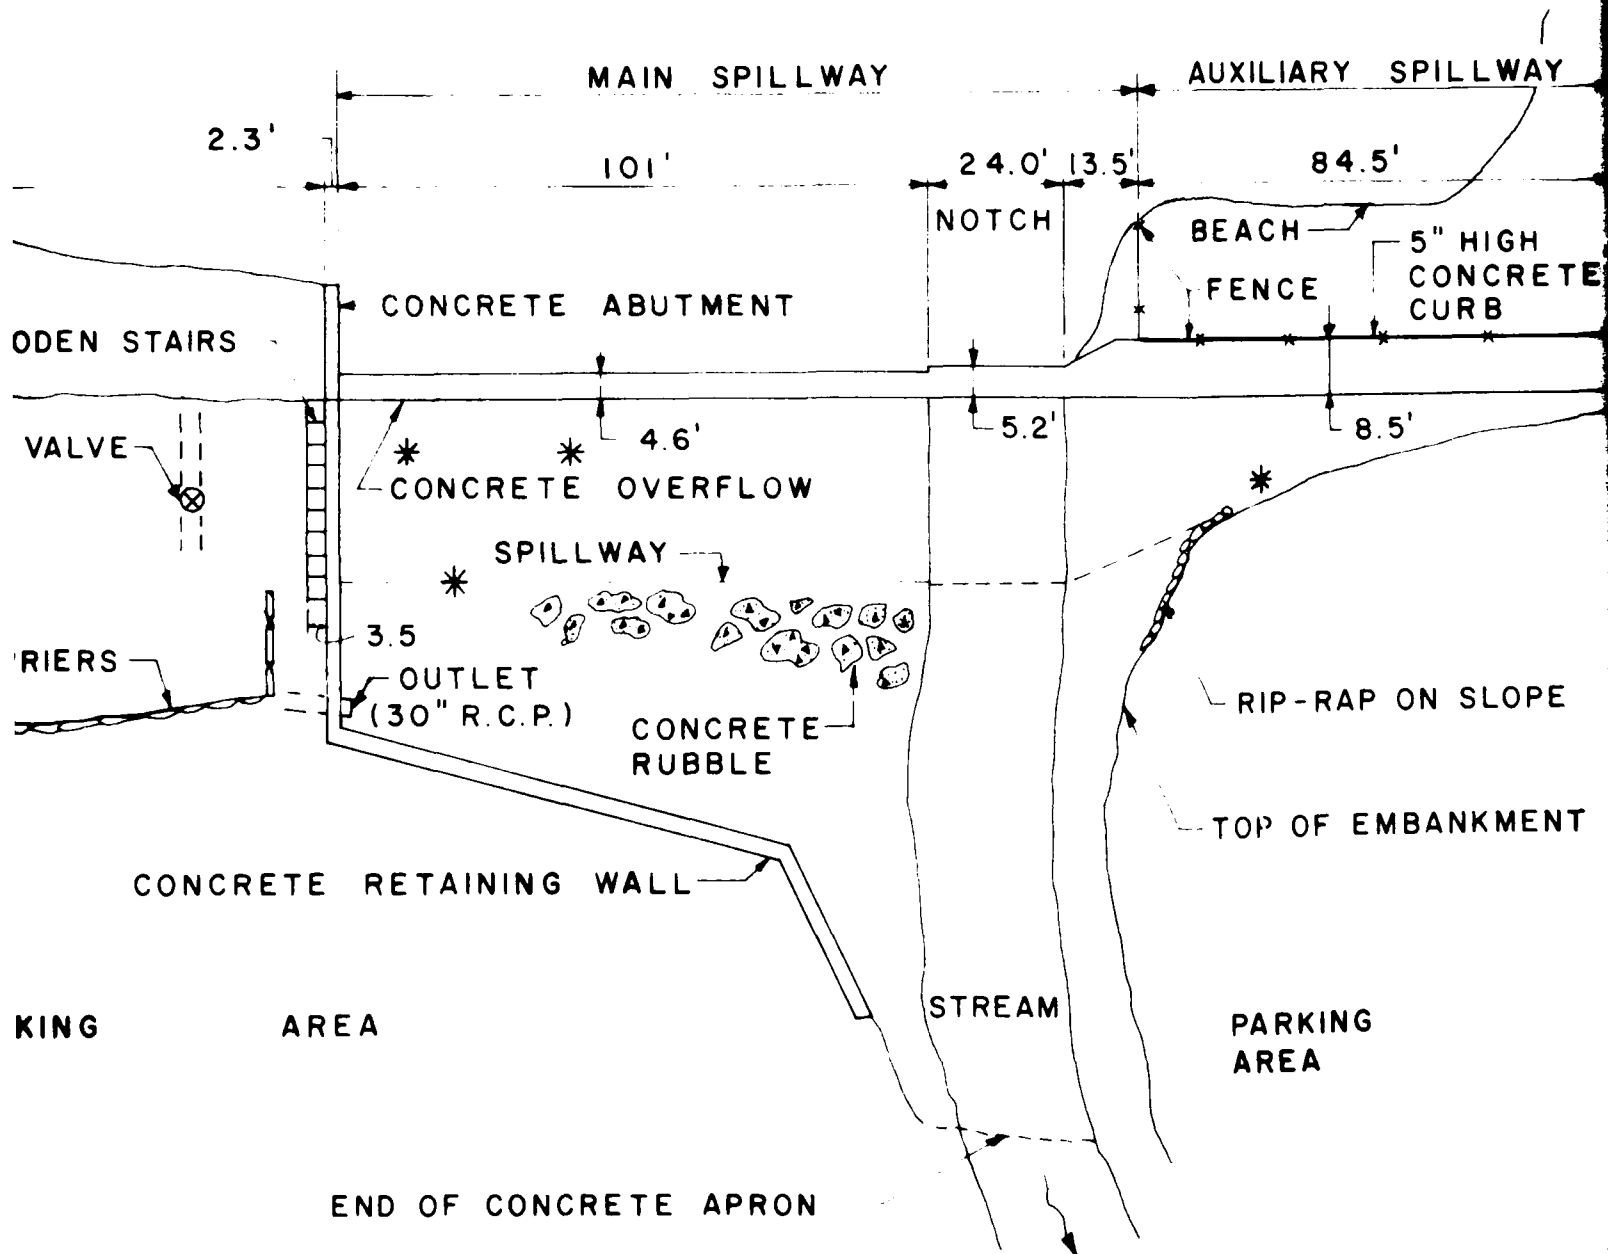
PLAN

OLD BROKEN
CONCRETE BARRIER
